Roman God Returned to Glory

Losing Weight by the Ton

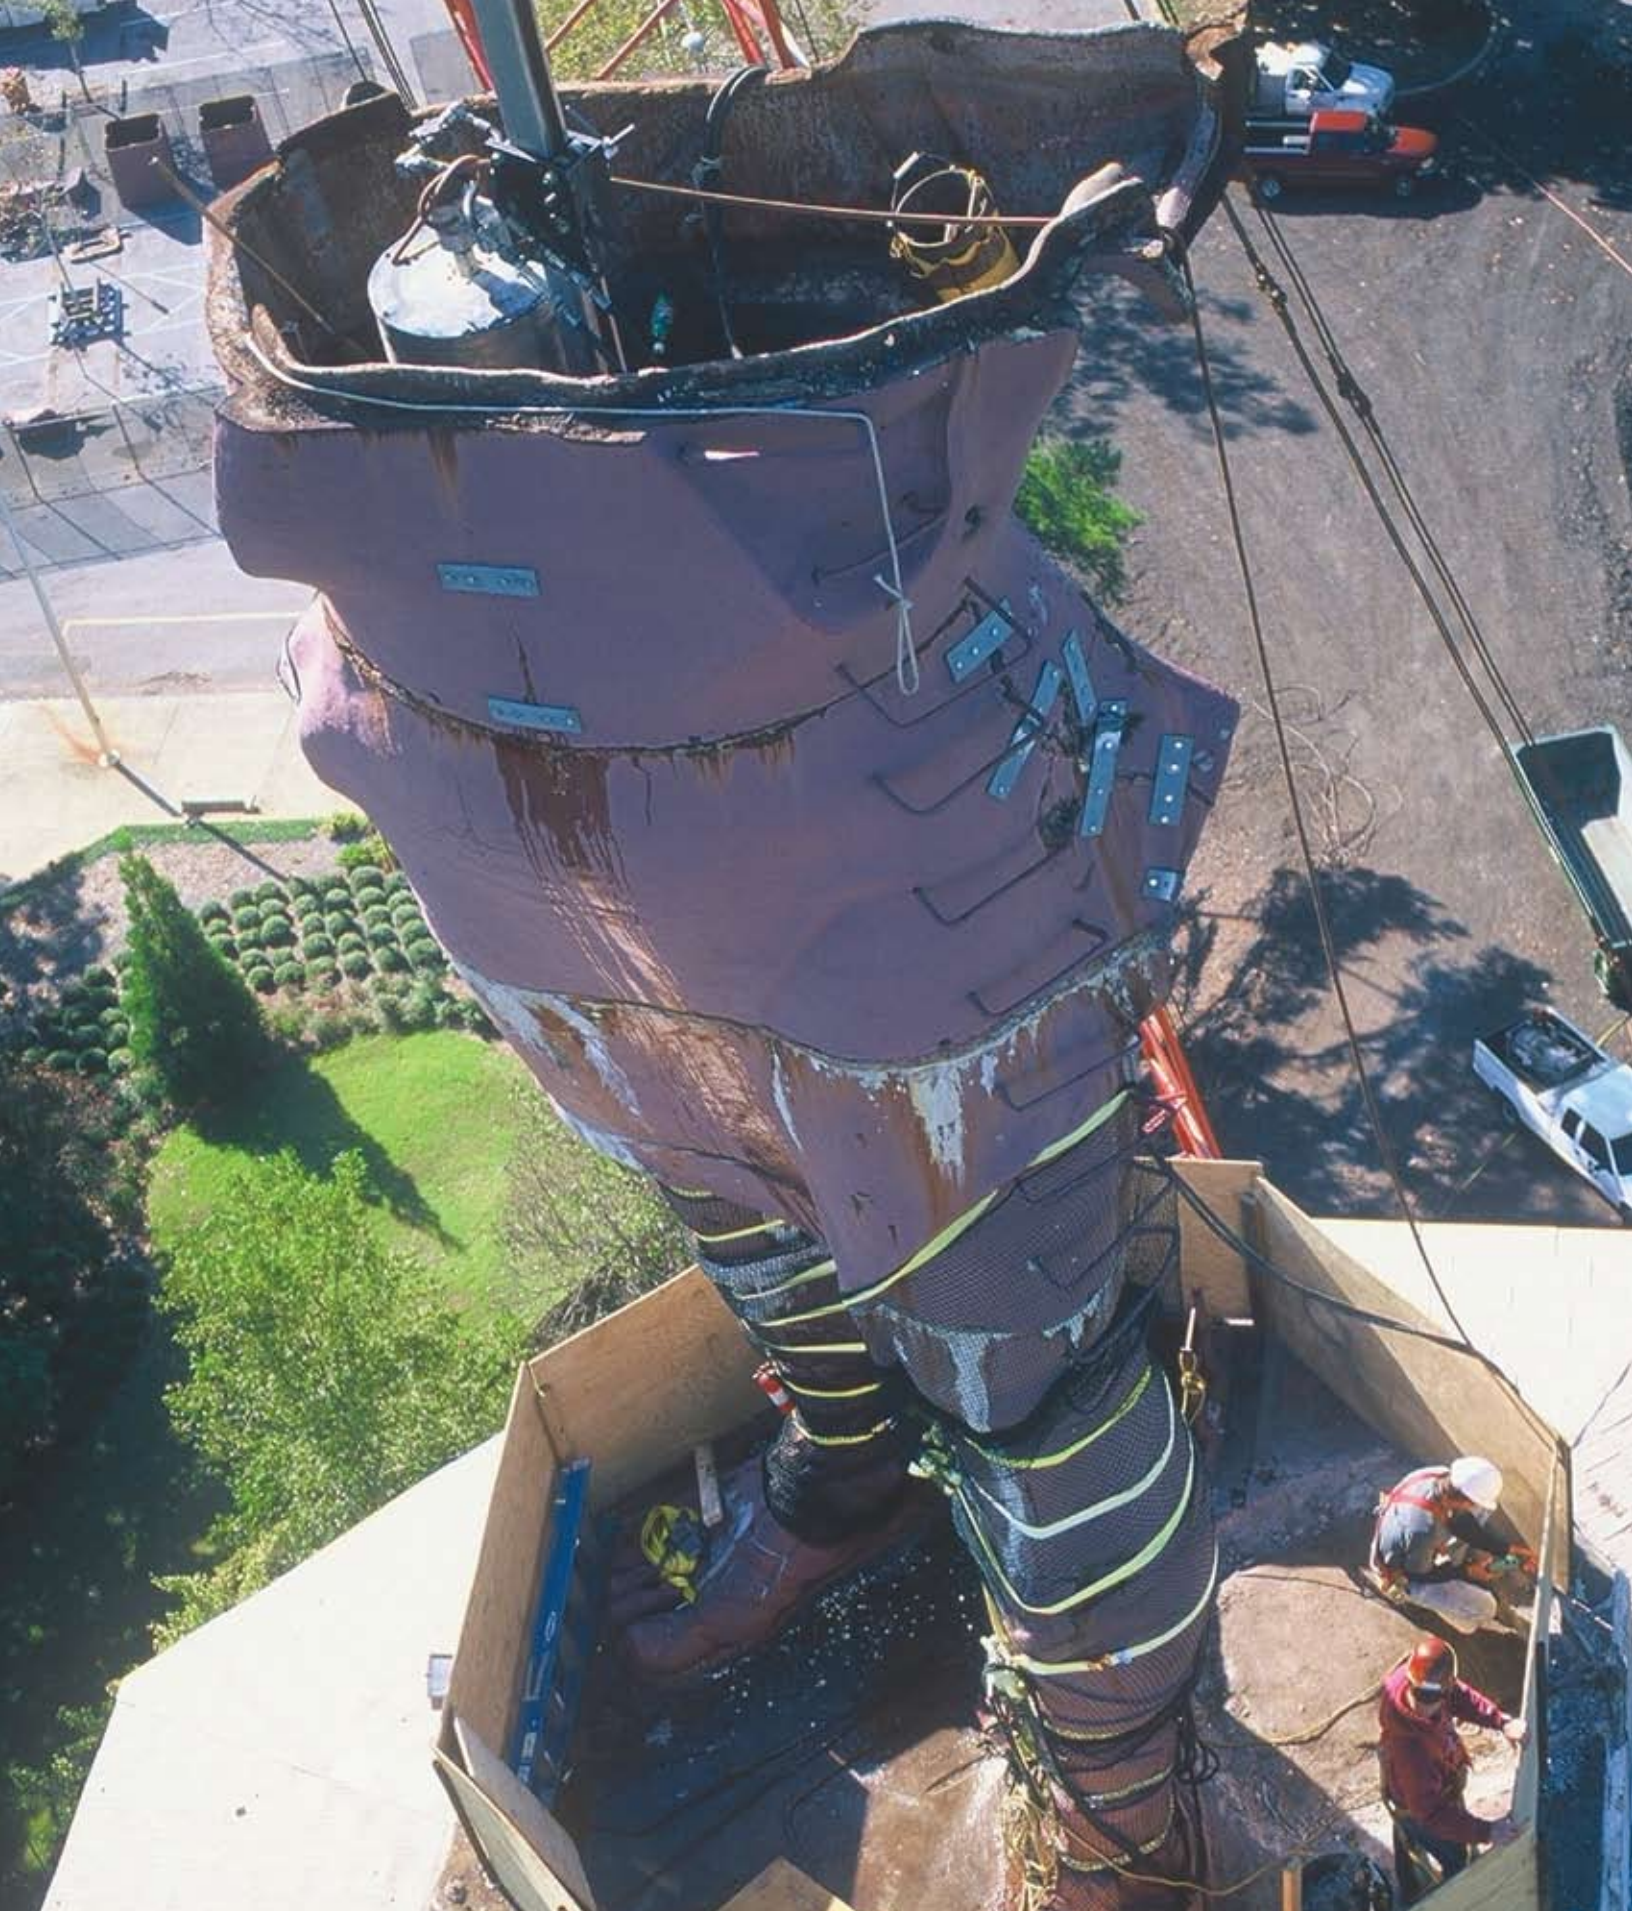
ABC operators worked at difficult heights with very limited access from their work surround.

To facilitate removal of the concrete, ABC core-drilled around the connecting flanges and bolts. Operators drilled core holes below the casting seams to help Robinson Iron’s employees remove the concrete from the irregular slopes of the castings. After each cast iron piece was lifted off, ABC would start the process again on top of the next casting, working down each one to the next seam. ABC’s operators removed approximately 32 tons of concrete ballast or 24 cubic yards. The three-man crew under the direction of field coordinator James Hugeness worked 4 ½ weeks on this phase. Area Manager Jeff Marshall worked closely to coordinate the wire sawing and core drilling crews with the needs of Robinson Iron.

When ABC reached the lowest torso section, operators discovered severe cracking of the cast iron. Steel City Crane Erection and Rental Inc. rigged its 250-ton crane with a spreader beam to lift both legs together with the lower torso. ABC used a diamond wire saw to separate Vulcan’s huge sandals from the pedestal. With two ½-inch dowel pins in the heel of each sandal cut, Vulcan was placed gently on the earth of Red Mountain, where he was stored and displayed until 2001. In late 2001,

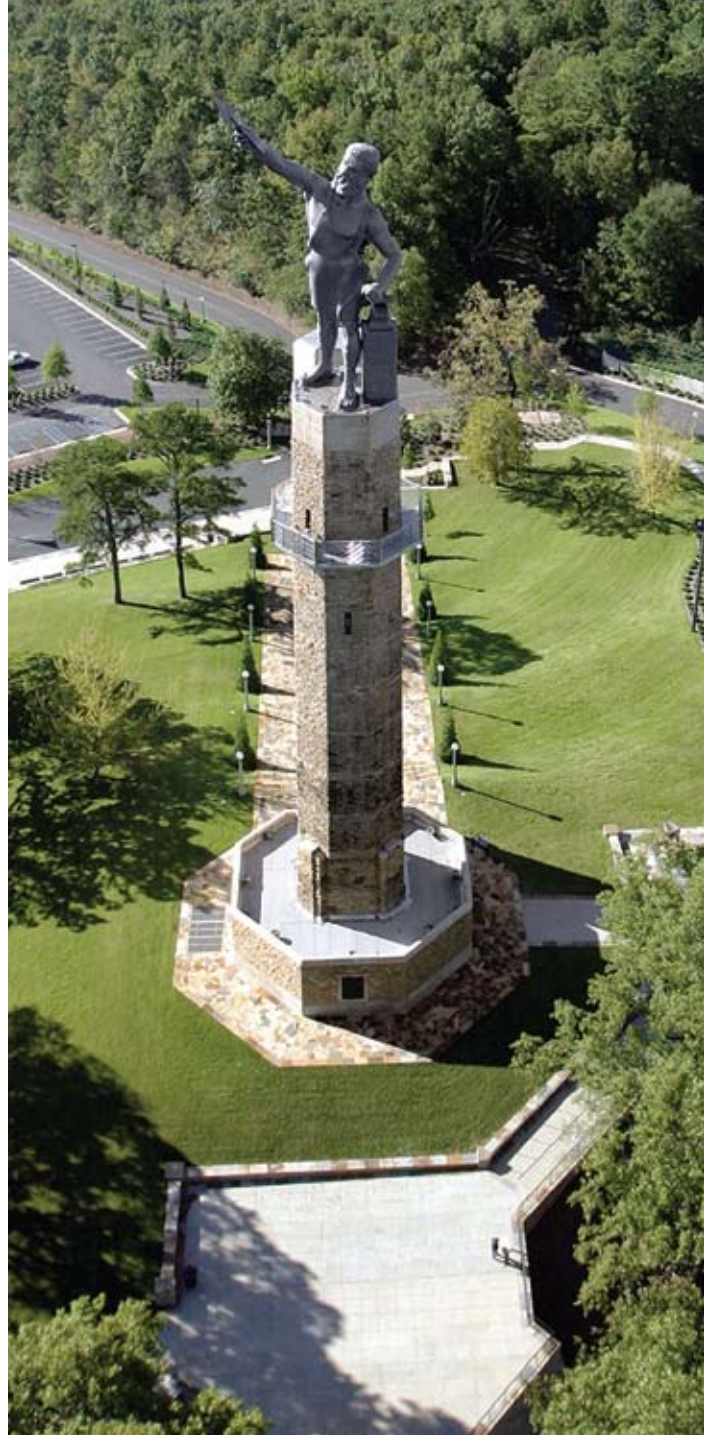
The renovated statue was placed on top of a new pedestal with observation deck.

Once the new pedestal was completed and ABC cut access openings to the top of the pedestal, they drilled 24 two-inch-diameter holes, 6 feet in depth for anchors to hold the newly restored Roman god in place. Vulcan celebrated his 100th birthday when the \$14 million renovation was complete and the park reopened in 2004. "Without the expertise of ABC Cutting Contractors we could not have completed this project in a timely manner. Their employees did a great job," said Scott Howell from Robinson Iron.
